# City of Lake Forest Bicycle Master Plan

## Community Workshops

## Discovered Areas Hazardous to Cyclists

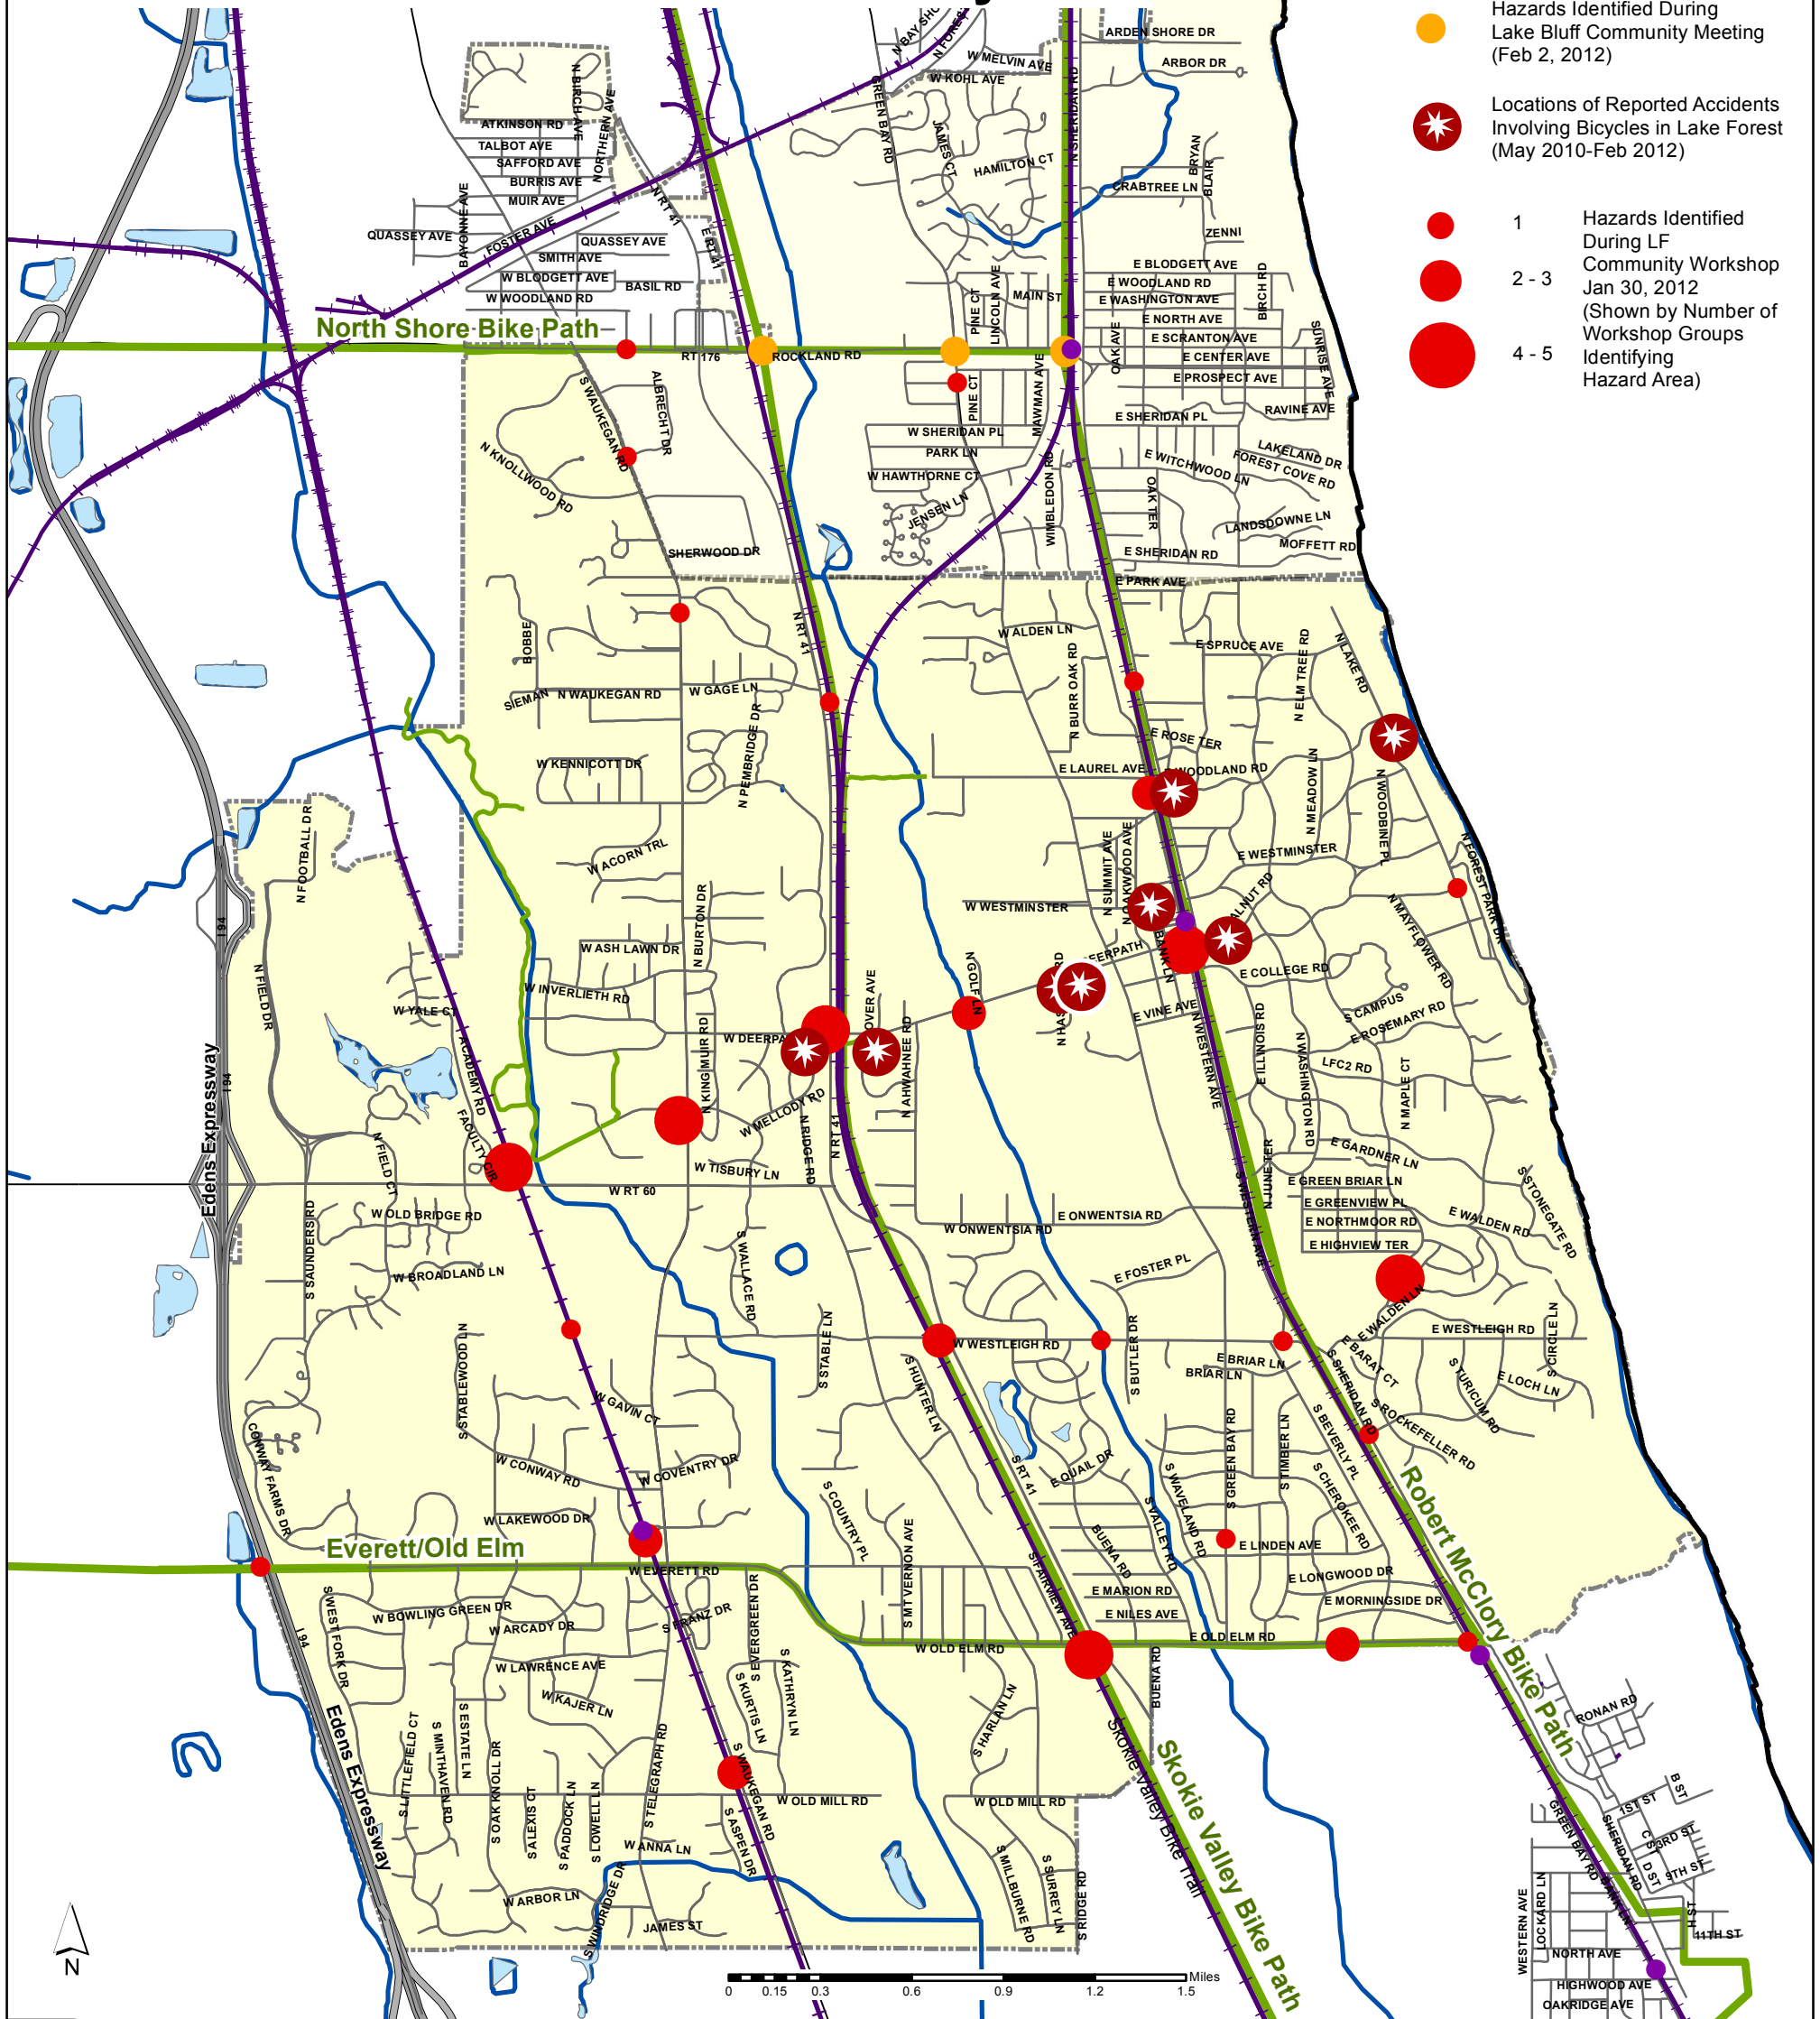
### Summary of Identified Hazards

#### Downtown Lakeforest:

- Bike Trail goes through parking lot
- Railroad crossings
- Limited access to stores on Western Ave and Market Square
- Limited Trail Access
- Lack of bike parking

#### Deerpath:

- Street is Narrow
- Number of curbcuts and driveways
- Intersection with Route 41
- Congestion at Deerpath Middle School

#### North Shore Bike Trail (Lake Bluff):

- Number of curbcuts and driveways
- Intersections with major roads
- Overhanging bushes

#### Route 60:

- High traffic volume
- Narrow shoulder at overpass

#### Route 41 Intersections:

- Deerpath/Overpass
- Old Elm
- Westleigh Rd

#### Waukegan Rd:

- Intersections and crossings
- Poor condition of roadway
- Limited access from the east

#### Everett/Old Elm

- Intersections with major streets
- Visibility of trail connections
- Difficult access to signed route
